# SF Rush the Rock

## Field Service Bulletin

### U17 Heatsink

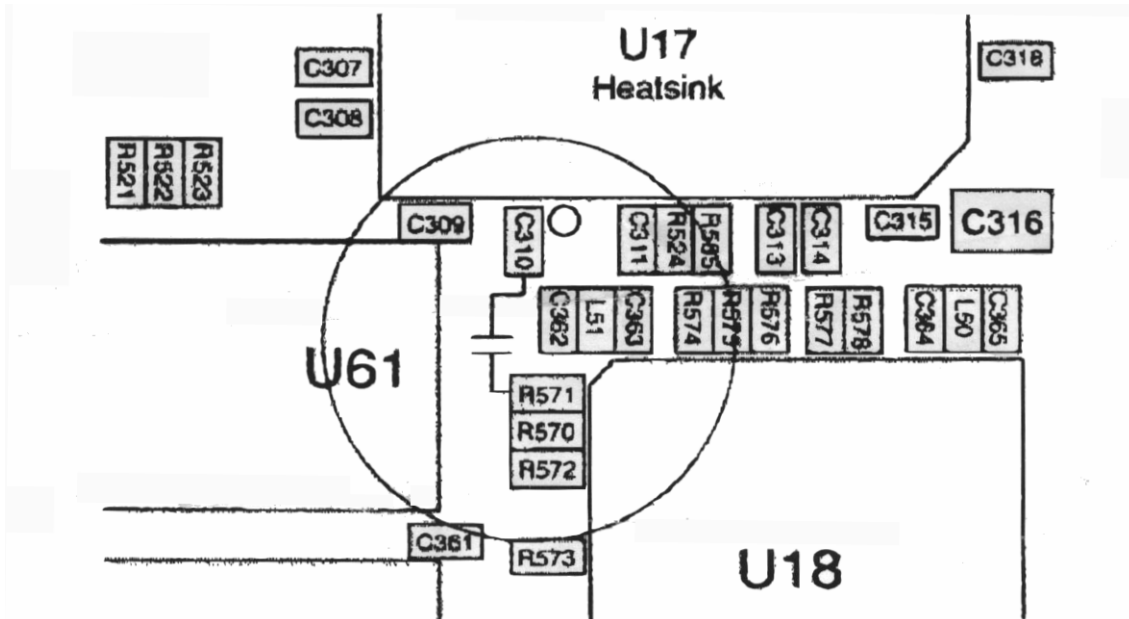
It has come to our attention that some **SF Rush the Rock** CPU boards (PN. #'s A-21937) may exhibit a reset problem. Symptoms are: the game freezes then re-boots during game play. To fix this timing error, solder a 10pF 10% axial capacitor (part # 5048-12503-00) from the load side of R571 to the ground side of C310. See below for an exploded view of the exact location on the board of the added capacitor.
